Manhole Inspection Summary

Manhole # S15QQ_013MH

Inspection ☐ Is Incomplete Rating: **3) Fair**

Location Address: **REAR 3114 TIOGA PKWY**

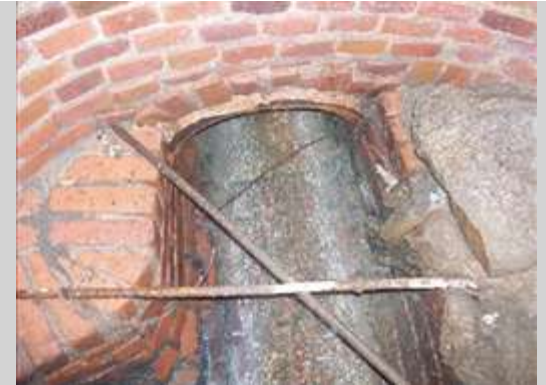
12 O'Clock Outflow

18 in. Circular Gravity Sewer
Pipe Out @ 12 O'Clock

Infiltration: **None** Pipe Seal Cond: **Sound**

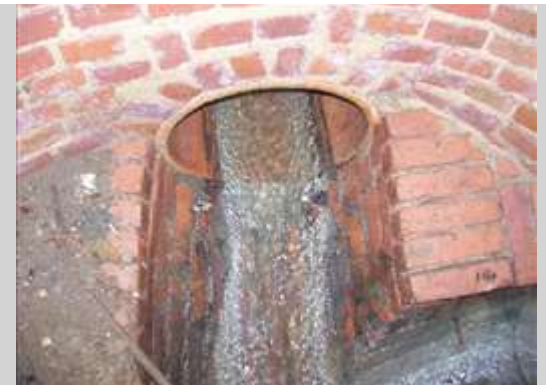
6 O'Clock Inflow

18 in. Circular Gravity Sewer
Pipe In @ 6 O'Clock

Infiltration: **None** Pipe Seal Cond: **Sound**

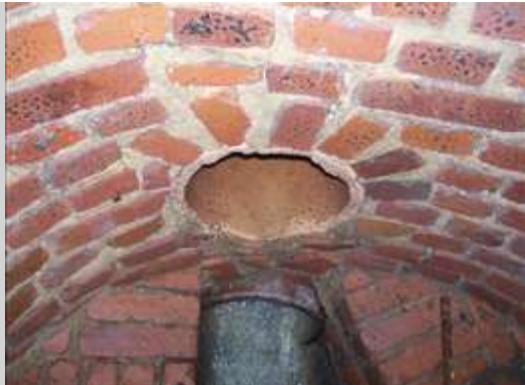
9 O'Clock Inflow

8 in. Circular Gravity Sewer

Pipe In @ 9 O'Clock

Infiltration: **None** Pipe Seal Cond: **Sound**

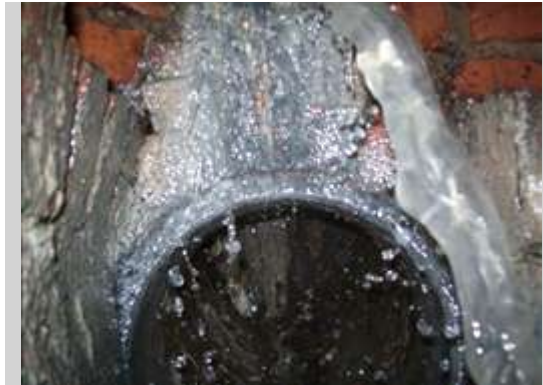
Drop In @ 9 O'Clock

Drop: **Outside** **Direct**

Drop Condition: **Open**
